## APPENDIX A

TO City of Ceres  
FROM Michael Nilsson, PlaceWorks  
DATE November 30, 2020  
SUBJECT **Ceres Active Transportation Plan Roadway Audit Summary**

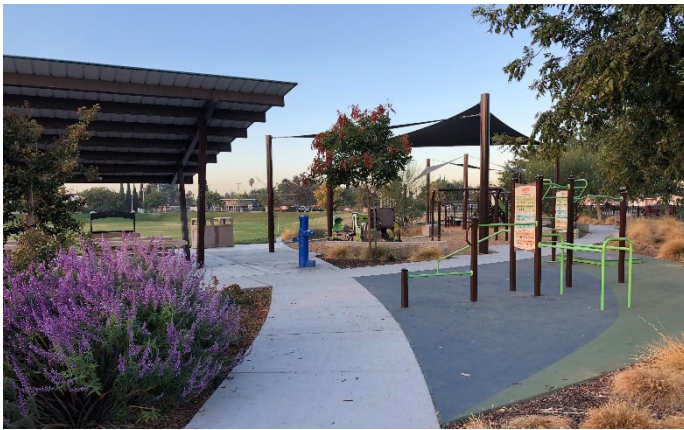
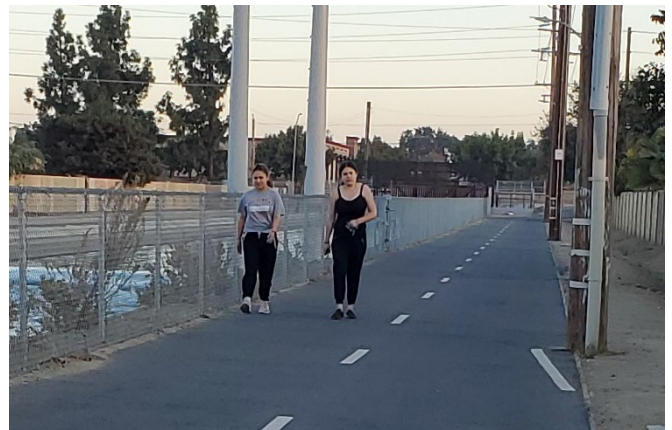
*The eastern neighborhoods of Ceres are adjacent to a number of walking and biking destinations, including Neel Park (left photo) and the east-west Class I trail just east of Mitchell Road (right photo).*

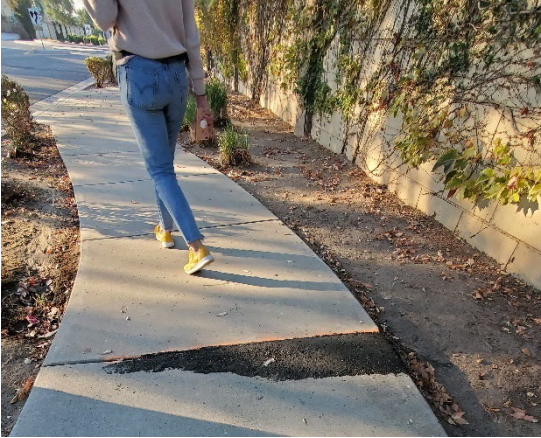
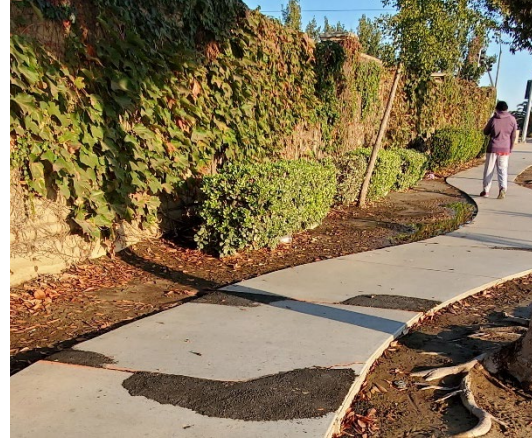
- **Quality and Safety of Sidewalks – (4.25, Good-Excellent).** Roadways within the Eastgate master planned community are in excellent condition, with the majority containing 5' sidewalks with landscaped parkways buffering the sidewalks and street lighting. However, in the sections of the roadway audit outside of the Eastgate master planned community (e.g., west side of Boothe Road, Fowler Road west of Boothe Road), sidewalks narrow to 4'4" in width, are occasionally broken or cracked, and often times do not contain landscaped buffers. Occasionally, these areas also have sidewalks that have less than 4'4" clearance due to power poles and street lights located on the sidewalk as well as driveways and curb cuts that are not ADA-compliant. While there are no sidewalks on either side of Hatch Road east of Mitchell Road, there is a multi-use path that directly parallels the south side of Hatch Road that is heavily utilized by pedestrians and bicyclists in surrounding neighborhoods.

*While most roadways in neighborhoods surrounding Neel Park in the Eastgate master-planned community contain well-maintained sidewalks with landscaped parkways, there are some sidewalks along Eastgate Boulevard, Boothe Road and Fowler Road that need maintenance. Pictured above are sidewalks along Eastgate Boulevard.*

- Considerations to improve sidewalks – Focus on implementing improvements to widen sidewalks as well as updating curb ramps and driveway aprons that will enable ADA compliance for all walkways in the roadway audit area. Consider installing sidewalks on Hatch Road once development occurs adjacent to the roadway.

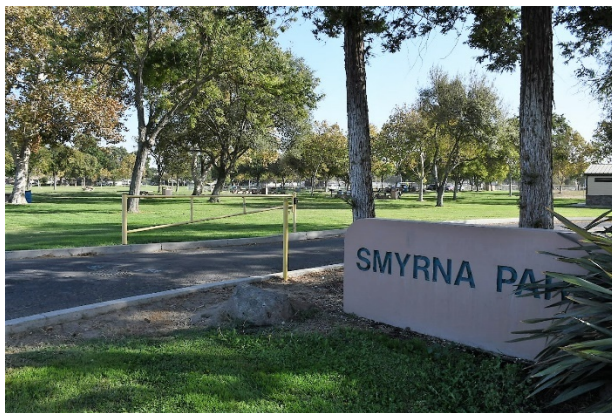
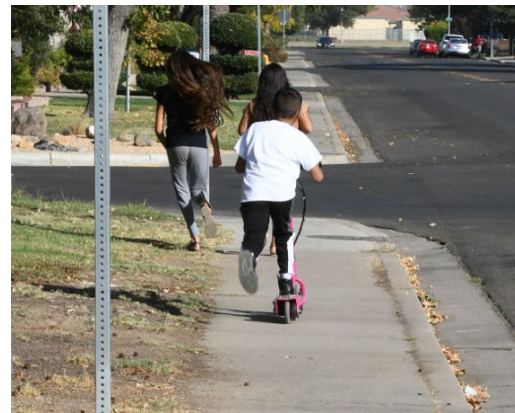
*Smyrna Park is a popular community park in central Ceres (left photo), which is also adjacent to Carroll Fowler Elementary School and Mae Hensley Junior High School. These destinations result in attracting many pedestrians and bicyclists along neighborhood roadways (right photo).*

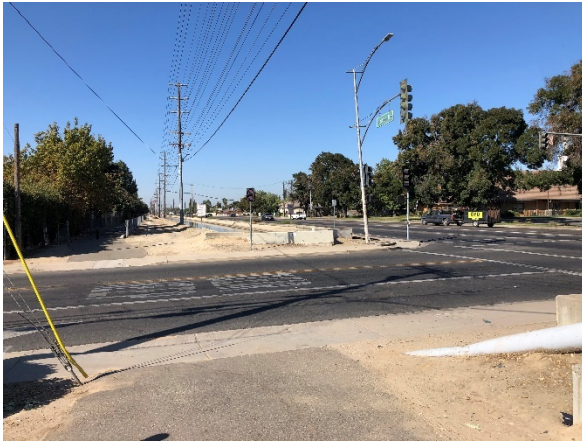
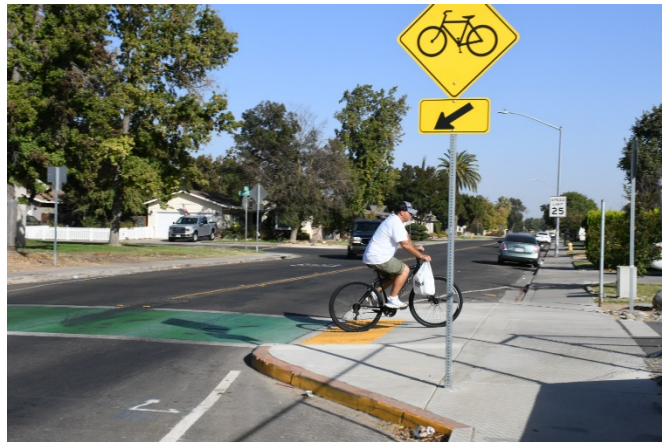
*Marked crossings should be implemented where Hatch Trail crosses Moffett Road (left photo), similar to the improvements instituted where the Class I Trail crosses Fowler Road just east of Mitchell Road (right photo). Where possible, Ceres should add marked crossings with identification signage when Class I Trails cross roadways throughout the City.*

- Considerations to improve safety of roadways, street crossings and intersections – Add striped crossings at all stop-controlled intersections. In addition, add signage, striped crossings and “keep clear” markings where the Class I trail crosses Moffett Avenue (just south of Hatch Road). Stripe dedicated bicycle lanes along Moffett Road, Rose Avenue and Fowler Road as well as adding sharrows along Glasgow Road and Garrison Street.

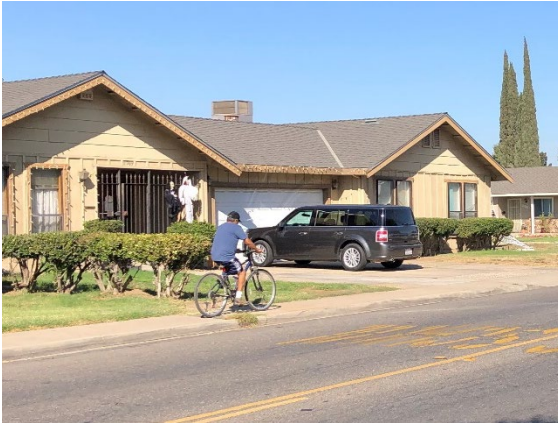
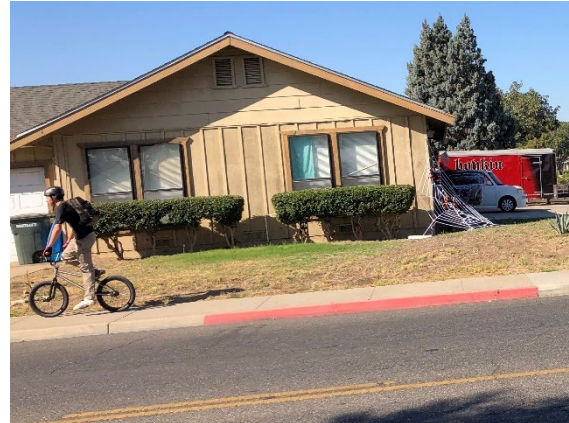
- **Quality and Safety of Street Crossings and Intersections – (3.66, Fair-Good).** While there are yellow high visibility zebra striped crosswalks at intersections directly adjacent to Smyrna Community Park, Carroll Fowler Elementary School and Mae Hensley Junior High School as part of Safe Routes to School improvements implemented in the area, there are numerous stop-controlled intersections along Moffett Road, Rose Avenue, Garrison Street and Glasgow Drive that are not striped. This includes the Class I trail crossing at Moffett Road (just south of Hatch Road). There are also no dedicated bike lanes along roadways in the area, resulting in auditors observing multiple people riding in the sidewalk along Moffett Road, Fowler Road and Rose Avenue during the time of the audit.

*It was observed that most bicyclists rode on the sidewalk along streets adjacent to Smyrna Park, as illustrated in the above photos above of bicyclists along Moffett Road near Mauna Kea Drive. Consider striping bicycle lanes along Moffett Road, Rose Avenue and Fowler Road to give dedicated space for bicyclists, calm vehicular traffic, and provide more sidewalk space to pedestrians accessing the area's many destinations.*

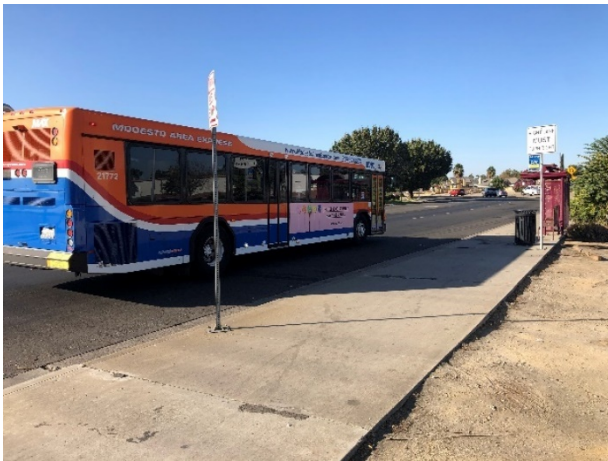
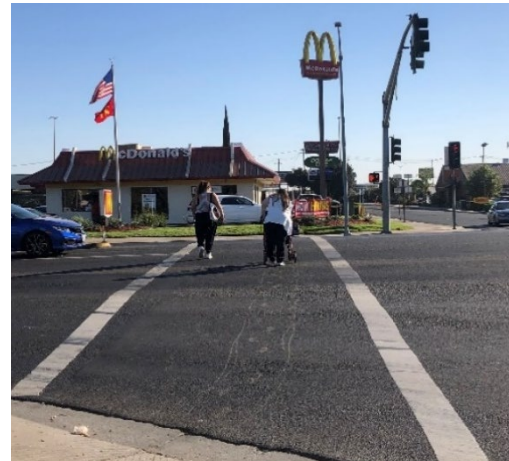
*The Hatch Road/Herndon Road intersection in Northwest Ceres contains the City's most frequent bus service, although the intersection is often challenging to pedestrians and bicyclists.*

- **Quality and Safety of Street Crossings and Intersections – (2.33, Fair-Poor).** Most signalized intersections along Hatch Road in the audit area only contain one or two striped crossings out of four intersection legs. Along Herndon Road, there are no striped crosswalks at stop-controlled intersections and the only intersection with striped crosswalks along Richland Avenue is at Hatch Road. Street lighting minimal along Herndon Road, especially south of Evans Road. While there is a Class I trail on the north side of Hatch Road, there are no other designated bike lanes in the audit area, although Herndon Road and Richland Avenue have very wide vehicle travel lanes.

- Considerations to improve street crossing and intersections – Install striped crossings at all legs of signalized intersections and stop-controlled intersections. Install additional street lighting along Herndon Road, especially south of Evans Road. Consider utilizing excess right-of-way to install buffered bicycle lanes along Herndon Road and Richland Avenue. Also consider installing more lighting and curb extensions at collision-prone intersections, including at:

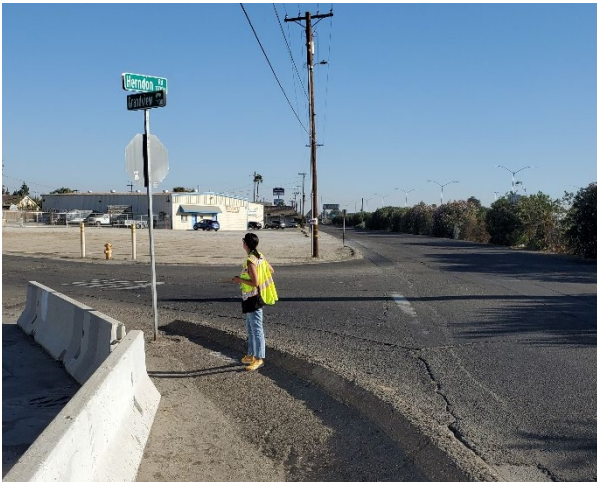
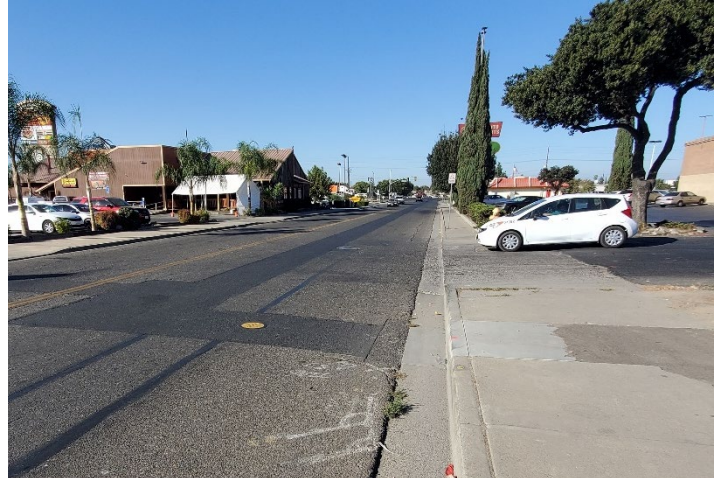
*Herndon Road in recent years has experienced a higher rate of collisions in comparison to other arterial and collector roadways in Ceres. Additional street lighting, striped crosswalks at intersections and improved maintenance of sidewalks will help improve walking and biking conditions and safety for all transportation modes along this corridor.*

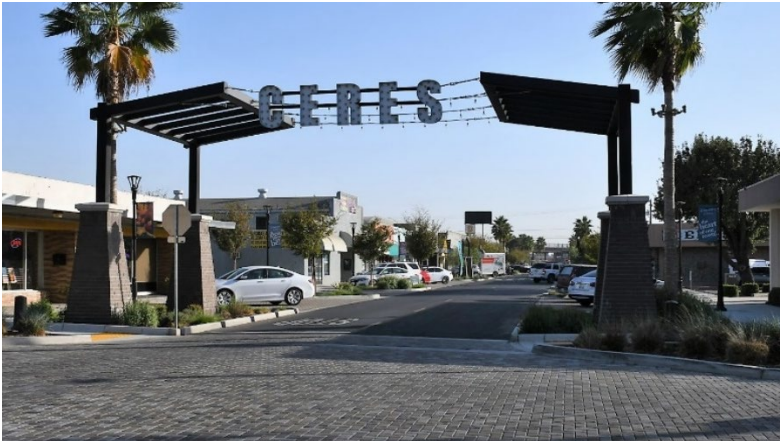
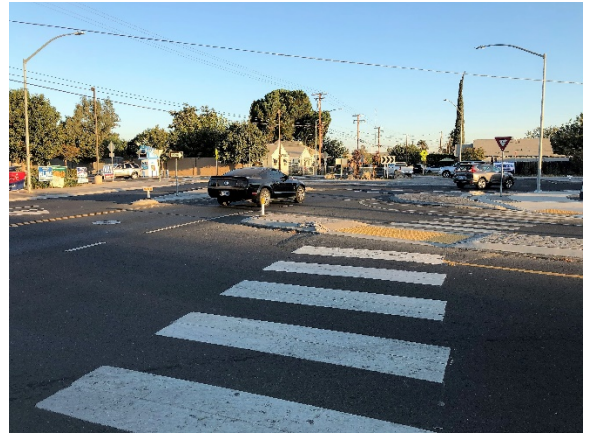
*A number of streetscape and transportation infrastructure improvements have taken place in Downtown Ceres and around the intersection of Central Avenue and Pine Street. More infrastructure improvements are anticipated to take place along roadways in Downtown Ceres and roadways west of Don Pedro Park in the coming years.*

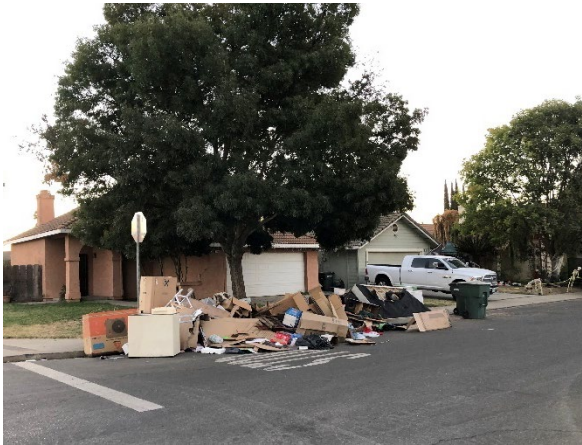
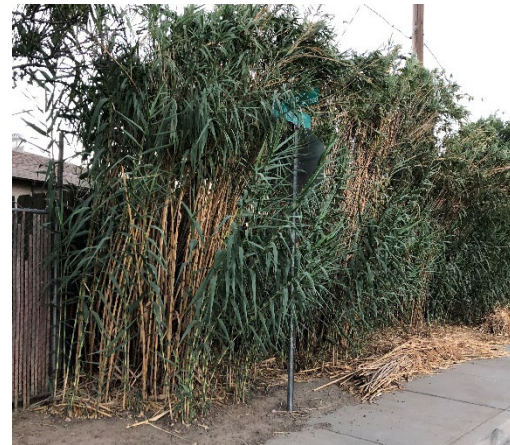
*More frequent code enforcement and removal of trash and litter (left photo) as well as replacement of overgrown landscaping and faded street signs citywide (right photo) will increase the comfort, safety and appeal of the roadway network in neighborhoods west of Don Pedro Park and throughout Ceres.*

- **Overall Comfort, Safety and Appeal of Roadway Segments Assessed – (3.5, Fair-Good).** Auditors noticed a number of areas where trash was dumped along sidewalks and on adjacent residential yards and vacant lots. These concerns were also raised by residents walking in Don Pedro Park during the time of the audit. Additional code enforcement alongside implementing transportation infrastructure will further improve and support walking and bicycling in the audit area.
- **Bicycle/Pedestrian Access to Future Ceres ACE Station –** With the proposed ACE Station opening in Downtown Ceres in 2022, the City should coordinate with ACE on safe pedestrian and bicycle access to and from the station site, including crossing and sidewalk improvements

- Considerations to improve street crossings and intersections – Replace older non-reflective street signs throughout the City of Ceres. Stripe crossings at all stop-controlled intersections and consider adding highly reflective zebra-striped crossings at intersections near schools, freeway interchanges commercial shopping areas or parks. Consider installing a roundabout with striped crossings at the El Camino Avenue and Pine/Park Street intersection to calm vehicular traffic, increase visibility for pedestrians and bicyclists and improve safety for all transportation modes. Consider striping a mid-block crossing at either Marazzi Lane or Walnut Avenue to support pedestrians crossing Blaker Avenue from Don Pedro Park into adjoining residential neighborhoods.

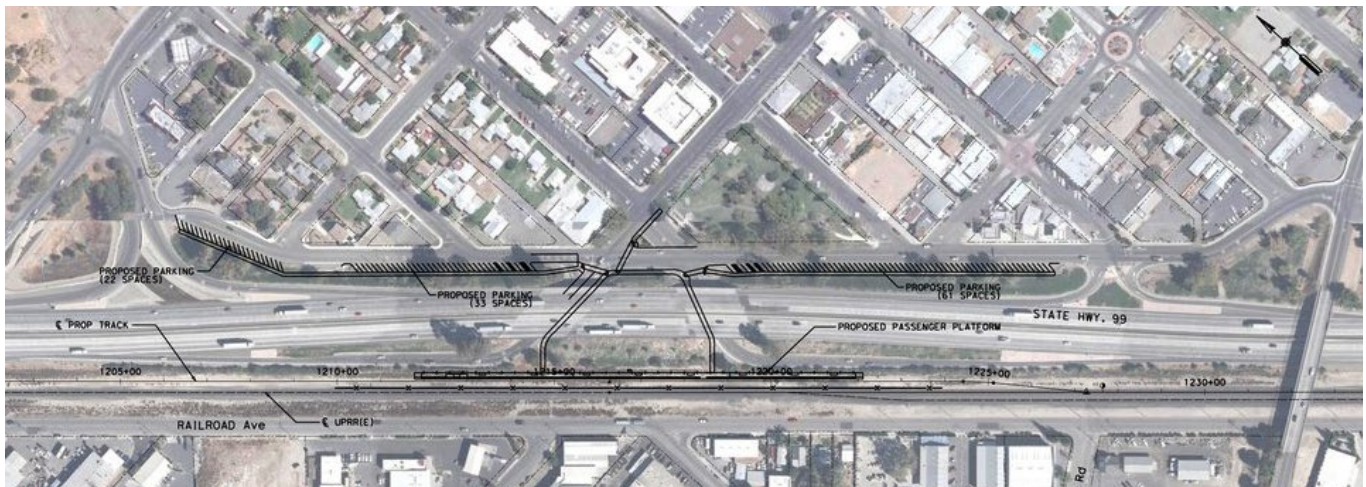
*Pedestrian and bicycle access enhancements should be coordinated alongside transit improvements associated with the proposed ACE Station in Downtown Ceres, which is expected to open in 2022.*

to streets intersecting El Camino Avenue between Central Avenue and 3<sup>rd</sup> Street. Ideally, a dedicated bicycle lane should be striped along El Camino Avenue prior to the opening of the ACE station. The existing Pine Street overcrossing should also be widened to better facilitate access to the train station from neighborhoods west of SR-99. The City should also consider whether there are any additional options to safely access the station from neighborhoods on the western side of SR-99. If it is determined that access from the western side of the train tracks to the train station is not feasible, barriers should be erected to discourage crossings to improve safety for pedestrians, bicyclists and train riders alike.

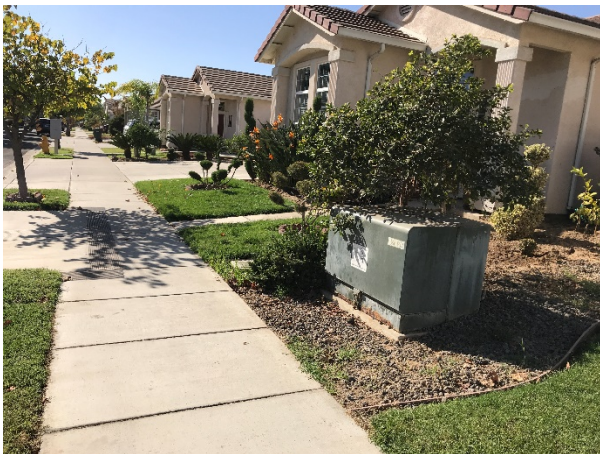
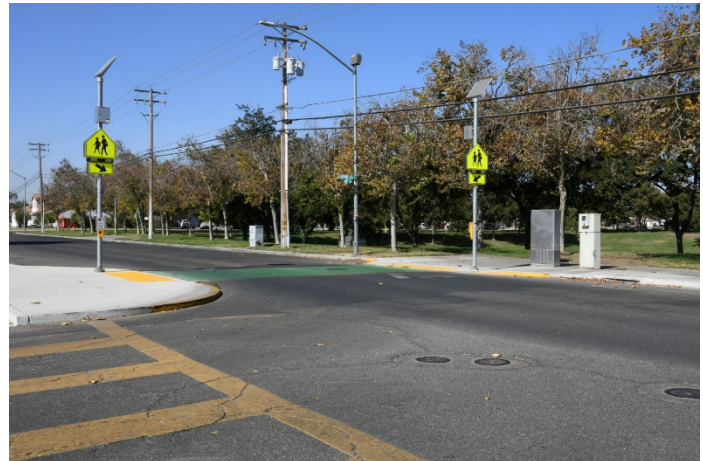
- **Quality and Safety of Street Crossings and Intersections – (2.5, Poor-Fair).** Striped street crossings are absent from all streets intersecting Brown Avenue, including at Stone Springs Drive and San Pedro Avenue adjacent to Sam Ryno Park. Other notable intersections where

*While the overall walking and bicycling environment in neighborhoods adjacent to Sam Ryno Park in west Ceres are pleasant (left photo), crossing improvements at more intersections throughout the neighborhood, such as those implemented at Esteban Avenue and Hackett Road (right photo), can further improve safety and comfort.*

- Considerations to improve street crossings and intersections – Incorporate striped crosswalks along all stop controlled intersections on Brown Avenue, Blaker Road, Morgan Avenue and Blaker Road. Stripe bicycle lanes along Blaker Road, Morgan Avenue, and Hackett Avenue to calm vehicle traffic and provide specific. Consider applying sharrows with signage along Brown Avenue, Don Pedro Road and San Pedro Road to Georgeann Lane.
